## Spontaneous Dissolution Mid-Shaft of a Double-J Ureteric Stent

Hemant Kumar Goel, Dilip Kumar Pal, Nipun Awasthi, Anupkumar Kundu, Shwetank Mishra, Vinod Priyadarshi, Praveen Pandey

**CITATION:** *UroToday Int J.* 2013 October;6(5):art 56. <http://dx.doi.org/10.3834/uij.1944-5784.2013.10.03>

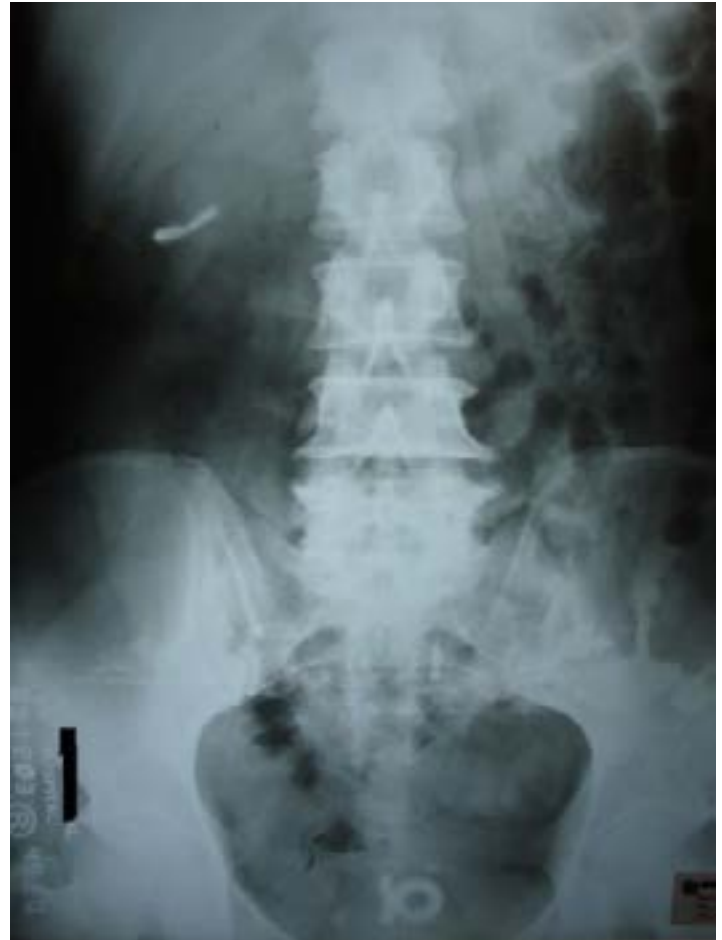
Figure 1. Plain X-ray KUB showing the upper and lower fragments.

administered. The lower fragment of the stent was removed by cystolithotripsy, and the upper fragment of the stent was removed by right-sided percutaneous nephrolithotomy (PCNL). No nephrostomy tube was placed but a new ureteral stent was given, which was removed after 3 weeks. Postoperative recovery was uneventful.

In our case, the upper fragment was removed via PCNL, and the lower fragment was removed via a cystourethroscopic approach. Great care should be taken to prevent any urethral trauma while removing an encrusted, calcified fragment. If a periurethral approach is considered unsafe, then one should not hesitate to perform percutaneous cystoscopic removal of the fragment.
